Federal On-Scene Coordinator's
Report
Immediate Removal Action
Turco Coatings Facility
Phoenixville, Pa.

Feb. 9, 1983 to March 11, 1983

REGION III
CERCLA EMERGENCY RESPONSE/IMMEDIATE REMOVAL ACTION

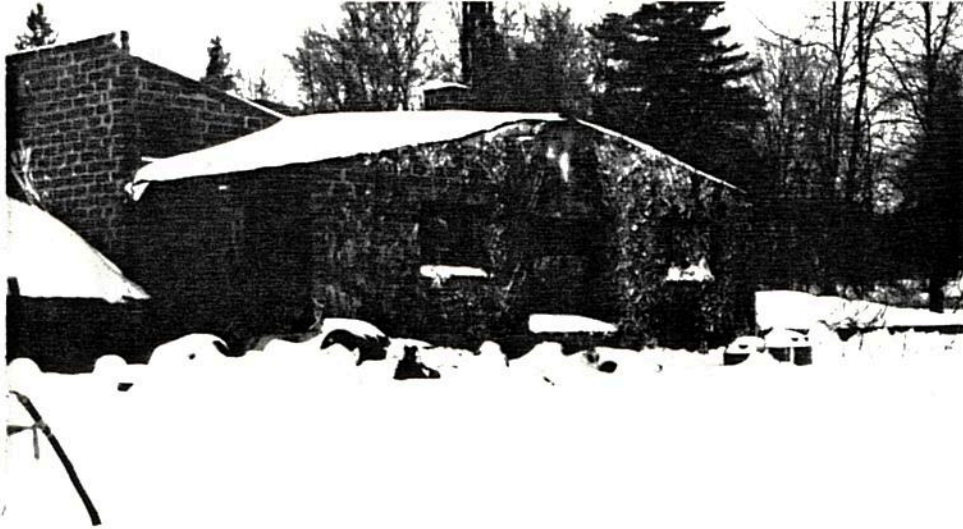
1. First day of operations, February 2, 1983 showing heavy snowfall and main drum storage shed.

On-site activities were hampered by inclement weather. During the first day of operations the area's largest snow storm in recent history occurred. Over 24 inches of snow fell, seriously hampering on-site operations. A warming period, soon after this storm, caused this snow to melt, which created extremely muddy conditions making it difficult to utilize equipment on-site. In anticipation of the heavy snowfall, the OSC contacted the prime contractor and requested immediate mobilization. Equipment, command post and support trailers were on-scene within the hour. Without this foresight, the removal may have been postponed for several days.

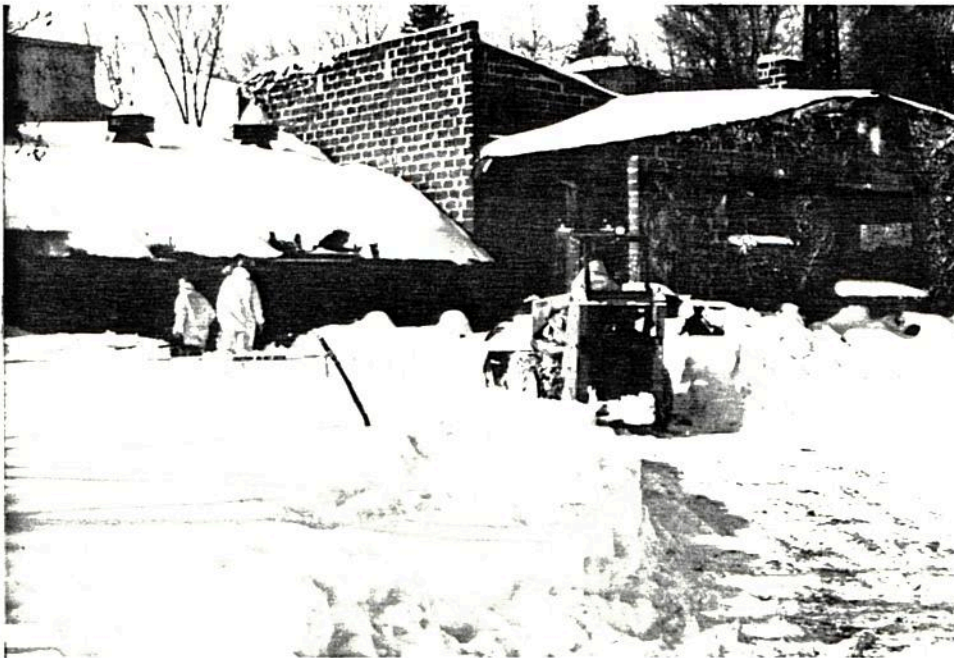
2. Workers clearing 24" of snow to create a drum staging area.

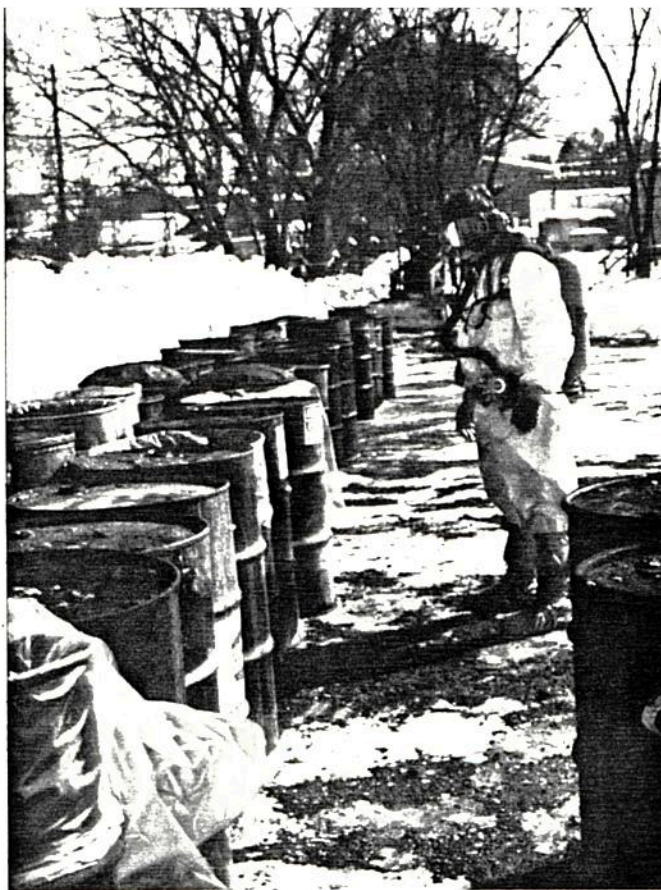
7. EPA Environmental Emergency Branch monitoring drum staging operation.

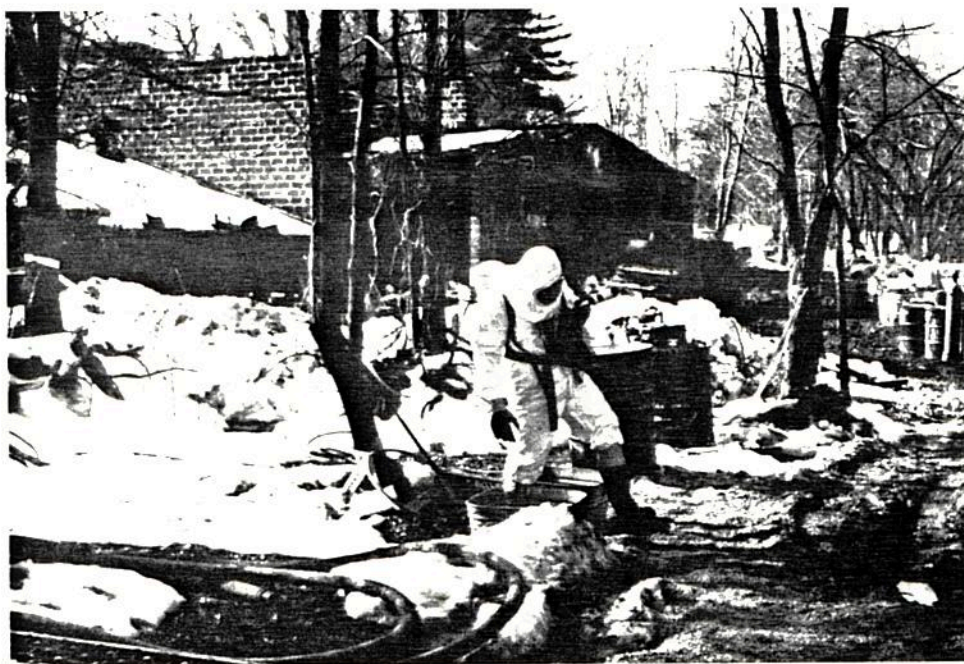
8. U.S. Coast Guard - Atlantic Strike Team member passes through decontamination zone (DRZ).

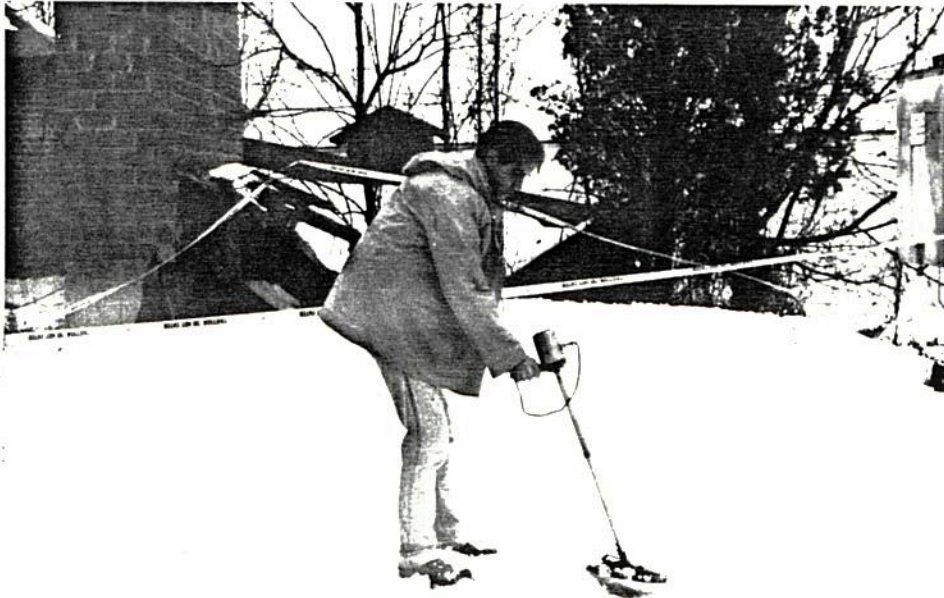
10. Frank Holmes, PADER OSC, uses a metal detector to search for buried tanks near secondary drum storage area.

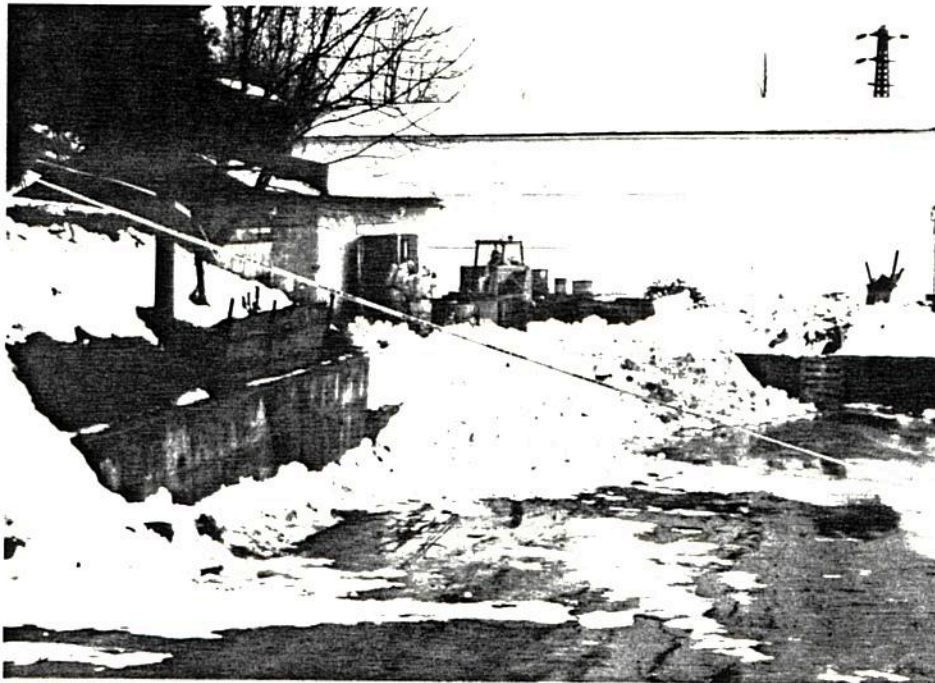
11. Secondary drum storage area - staging operations. Shows proximity to local industry (background).

The secondary storage building was in extremely, poor condition. A section of the roof had collapsed thus creating a safety concern.

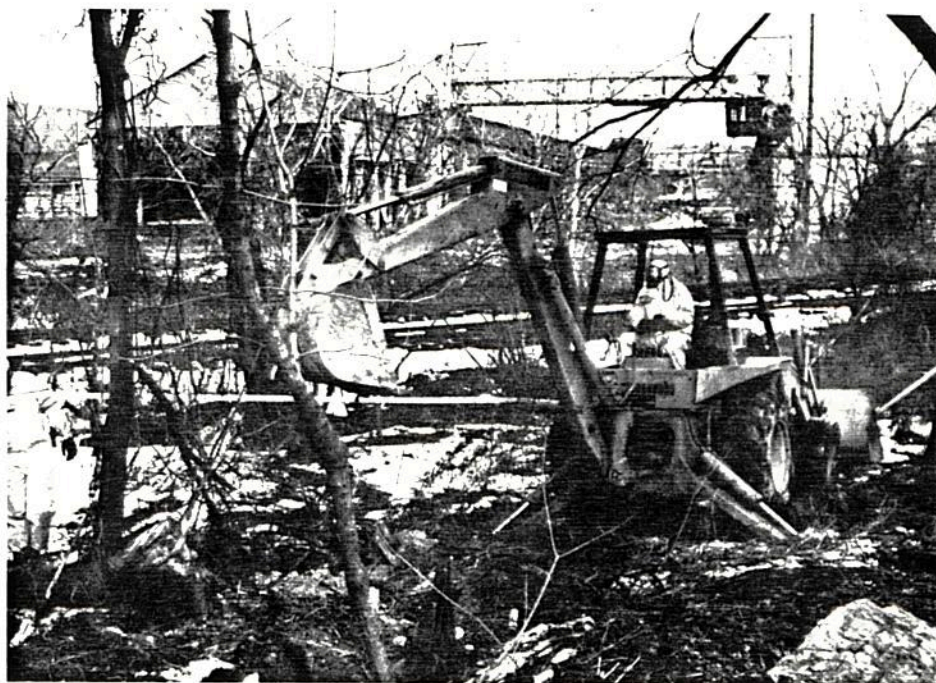
13. Backhoe removing drums from burial area adjacent to railroad tracks.

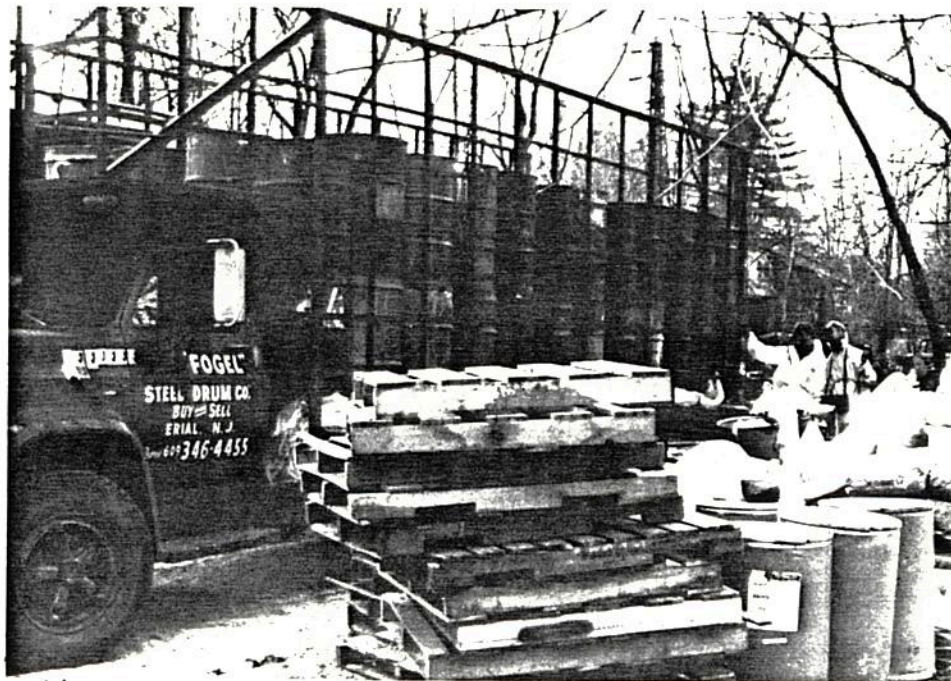
16. In an effort to minimize disposal costs, acceptable emptied drums were taken by a drum reclaimer.

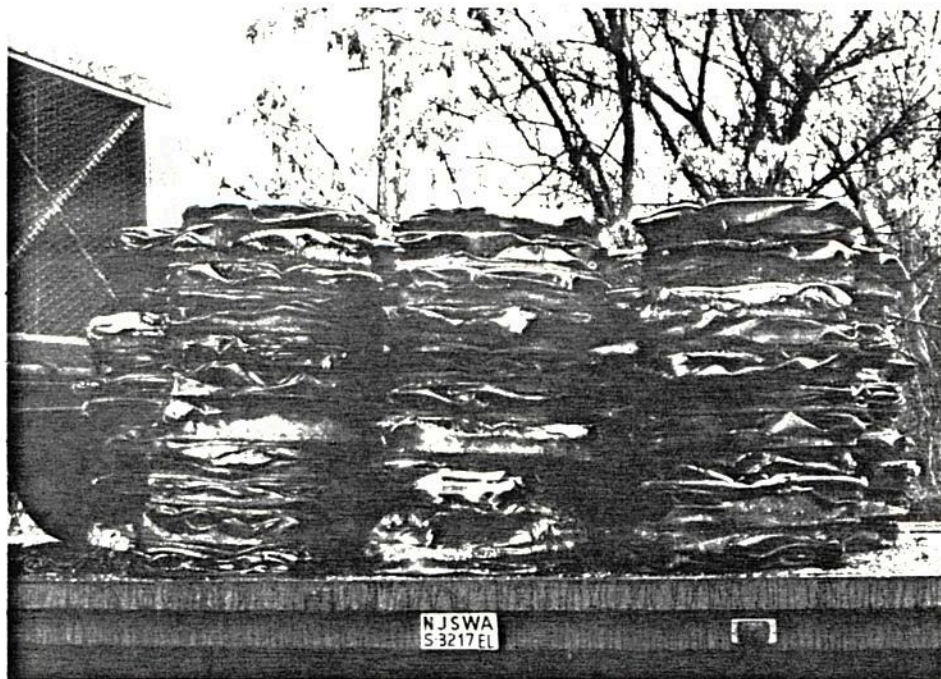
17. Drum unacceptable to the reclaimer were crushed for disposal.
